Service Letter #: SL04-35A-45025

Part/Assembly #: 35A-45000 Main Gear Installation, Actuator Mount

Float Model Affected: Model 3400 (All)

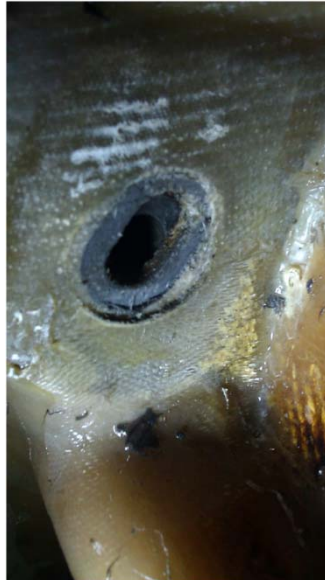
- 6) Visually inspect (with the aid of flashlights, mirrors, etc.) the condition of the bolt hole. A worn hole will have become oblong, allowing some movement of the actuator and allowing water leakage in this area. This condition is the result of wear caused while the actuator is in the retracted position - the main gear in the deployed condition. The hydraulic actuator exerts a great amount of force

between this hole and the stop bracket (not shown) in the gear well. Normal wear, accentuated by debris is the most likely, but not the only possible cause.

Figure 1 – Showing inspection Side view. (See Figure 2 for Top)

Aerocet offers a reinforcement kit, 35A-K45025 which increases the bearing area around the hole by bonding a reinforcement to the affected area. This information will also become available in later versions of the Aerocet service and maintenance manual and Illustrated Parts List.

If this condition is found during inspection, then follow the instructions offered in the drawing provided in the kit before returning the aircraft to service.
