**Service Letter #:** SL07-35A-45050 Shear Pin

**Part/Assembly #:** 35A-45050 Shear Pin

**Float Model/Aircraft Affected:** Aerocet Model 3400 Amphibious Floats, Serial #330 and later, and any earlier floats in which cotter style shear pins have been replaced with the retaining ring style. (35A-45050, I/R is cotter pin style, while 35A-45050, Rev A is retaining ring style.)

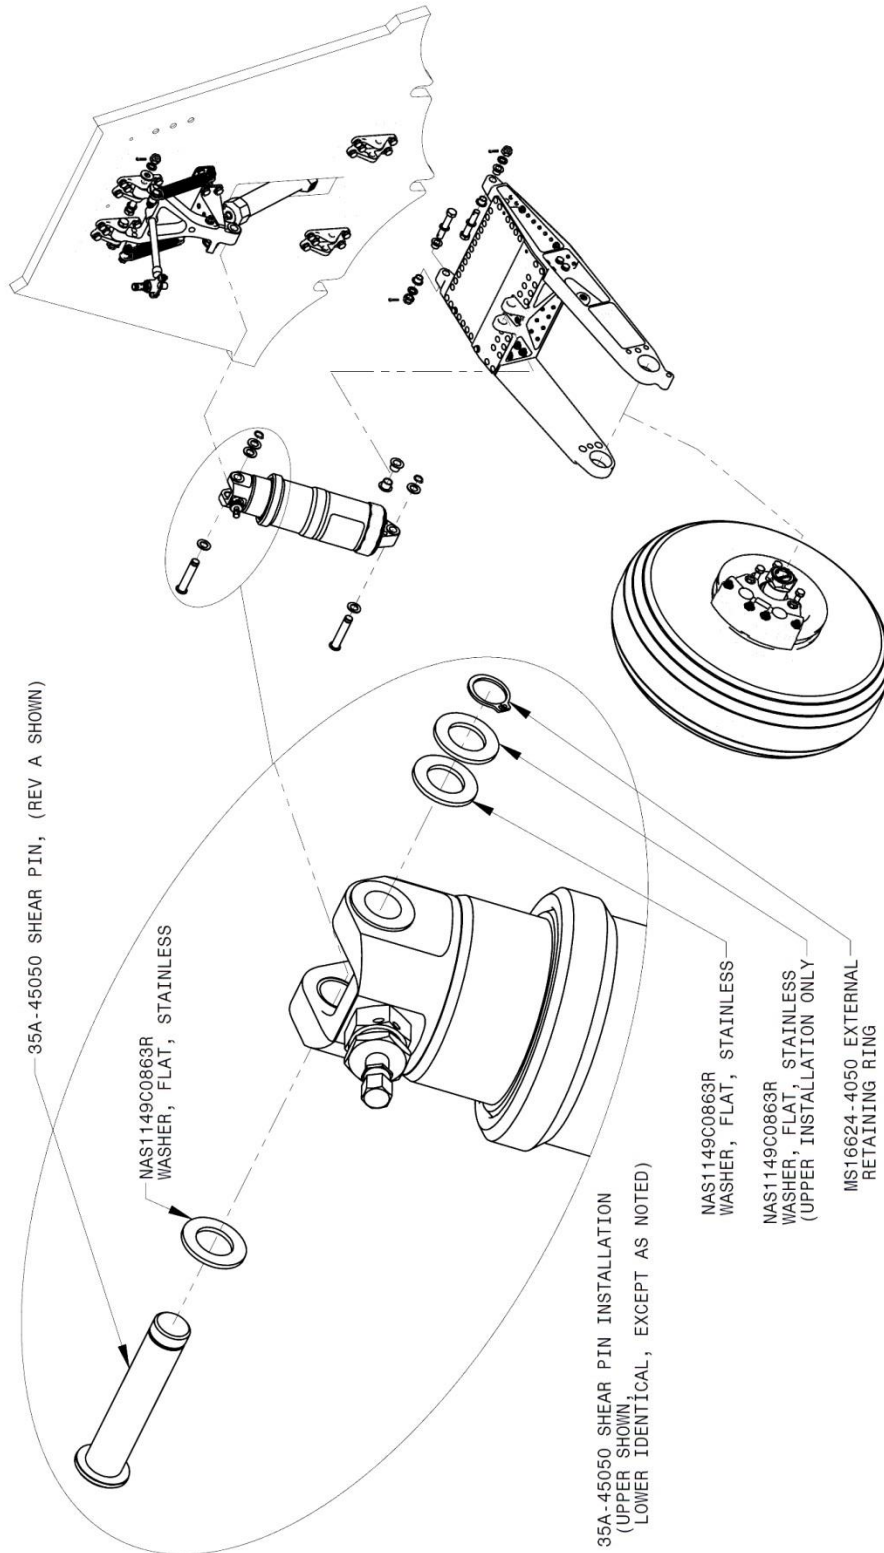
**Symptom:** MS16624-4050 Retaining Ring yielded due to over-spreading on installation.

It has been discovered that mechanics have overstretched the retaining rings that hold these pins in place upon either installation or removal of the shock strut reducing their retaining ability. As a result, retaining of the shock strut connecting pins may be lost.

**Figure 1 - Showing Main Landing Gear and 35A-45050 Pin Installation**

Assure that the connecting pins for the main gear shock strut (oleo) are secured (both top and bottom) with their respective retaining rings (Circlips, snap rings). (See Illustration on following sheet)

A further examination should be done by reaching in and rotating the retaining ring(s). If the retaining ring(s) rotates easily (no drag) then it likely has been overstretched and should be replaced.

**Any reinstallation of these connecting pins should be done with new retaining rings.**
