SERVICE LETTER SL21 66-47200 Rev A

Service Letter #: SL21 66-47200

Float Model Affected: Aerocet Model 6650 floats

Affected: Hydraulic Pump Motor

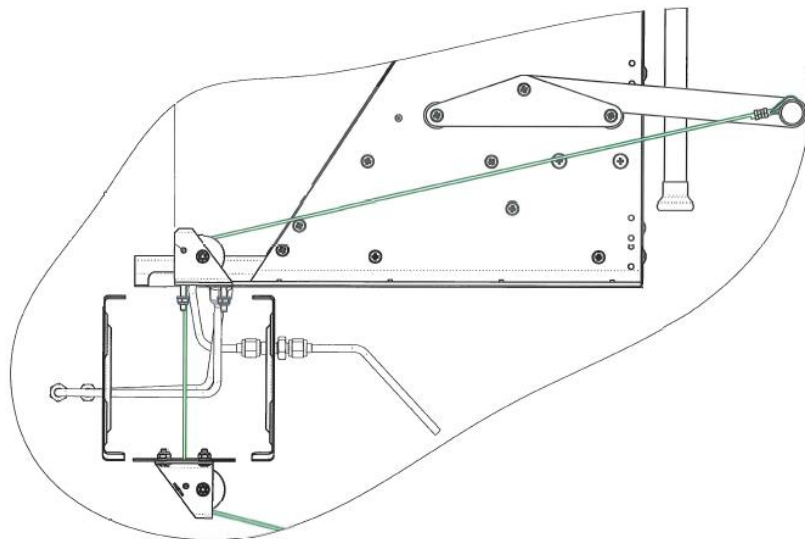
1. Aerocet is sending to you part # 66-47200 which is the complete pedestal, hydraulic assembly so that you will not experience significant down time.
2. Recommend moving pilot seat full aft or removing altogether for easy access.
3. Remove cable from water rudder retract handle.

Caution: Weight of rudder will need to be lessened to ease removal.

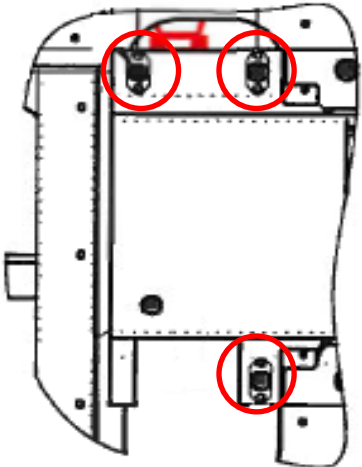
4. Remove 3 screws from hydraulic shield.

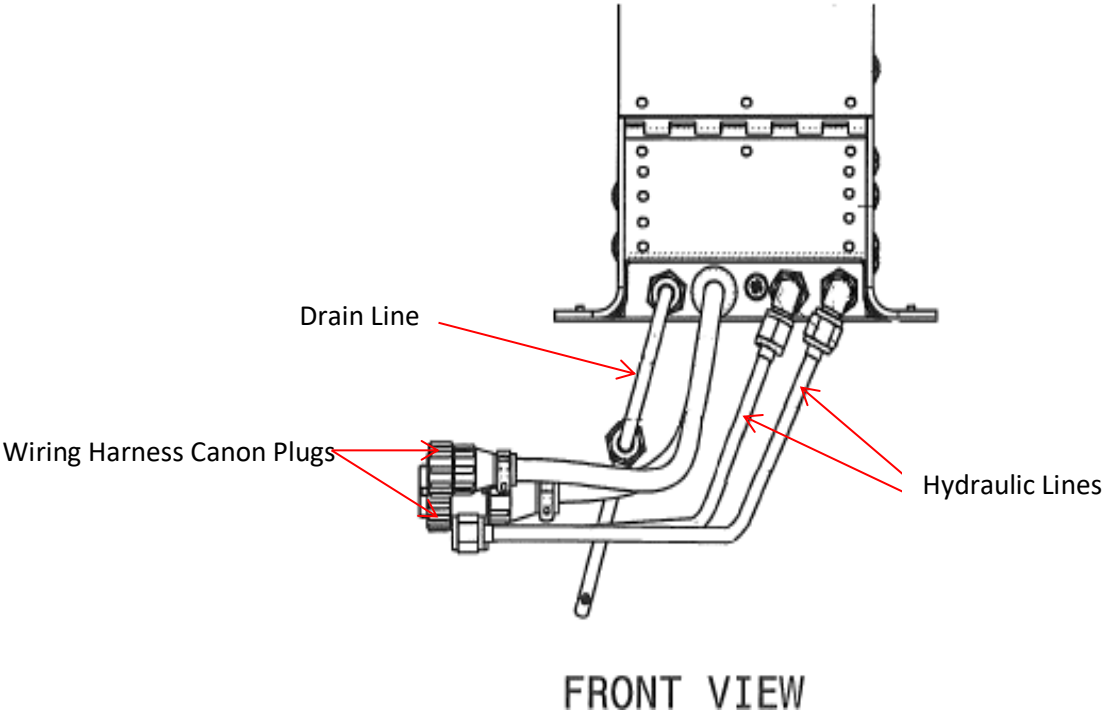
6. Disconnect 2 hydraulic lines and one drain line from front of pedestal. Cap and plug as necessary.

7. Under floor, disconnect two-wire harness canon plugs. (See above)
8. Remove pedestal from aircraft
9. Replace existing pedestal with supplied pedestal in same order as removal.
10. Call (208) 448-0400 for shipping voucher number and ship existing unit back to:
