SERVICE LETTER SL31 66-12020 Rev A

1. **Release Date:** August 29, 2017
2. **Service Letter No.:** SL31 66-12020
3. **Reason for Change:** Dimensions between key areas of floats
4. **Part/Assembly No.:** Drawing 66-12020
5. **Float Model Affected:** 6650
6. **Disposition of Product in Field:** Informational Only
7. **Approval:** All information provided is in accordance with approved data.
8. **Corrective Action:** (Informational Only)
9. **Time Required:** N/A
10. **Payments:** N/A

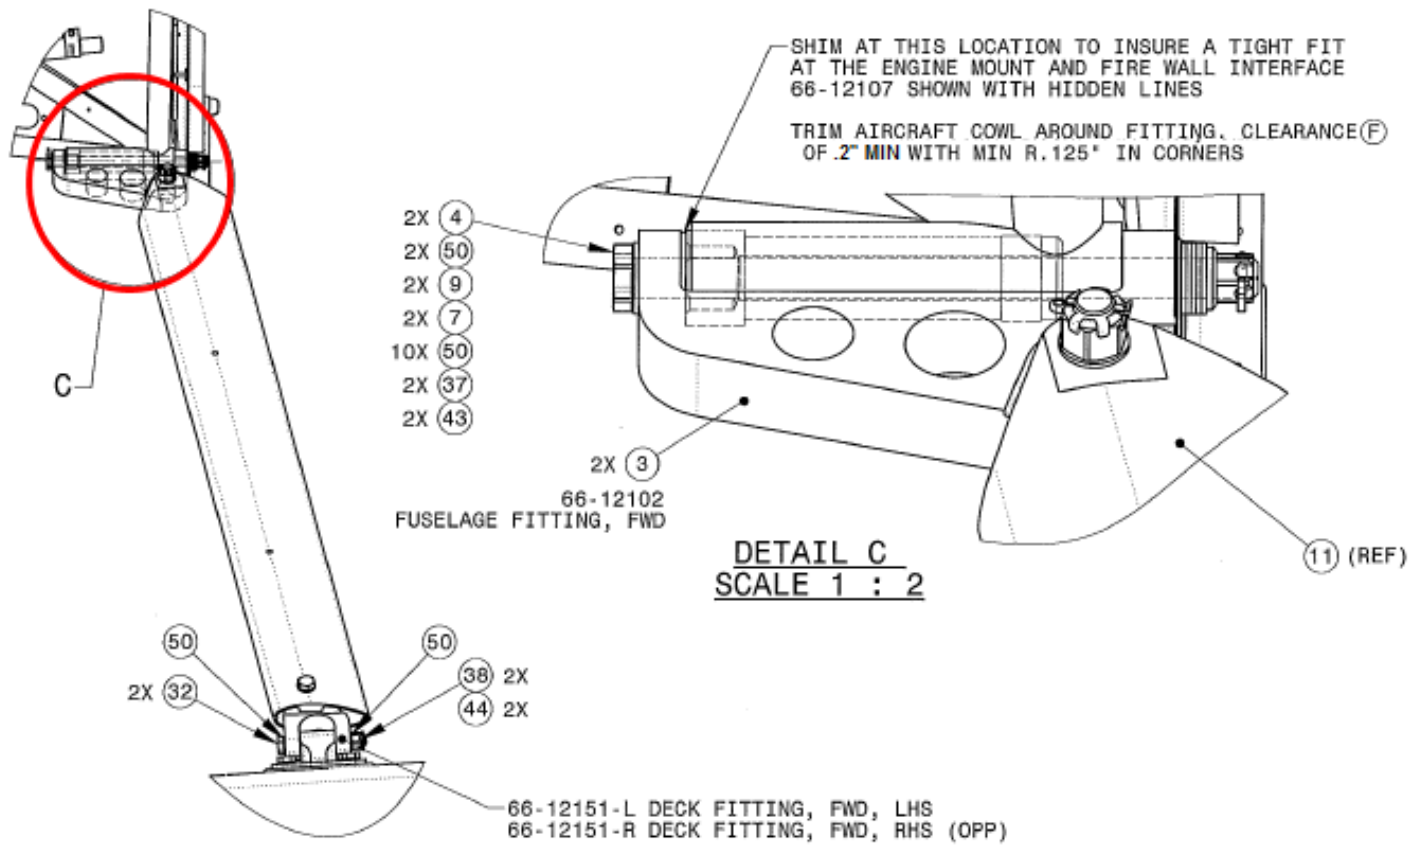
Figure 1: Shim Location 66-12020

1. There should be a minimum .2" opening around the fitting including the fuselage flange ahead of the firewall. See Figure 1 below.
2. There is some rotational movement on the front fitting. This gap should be opened to keep this from happening.

3. Any damage can be cleaned up as there is nothing structural in this area on the flange of metal or cowling.
4. Rotations for takeoff (VR1) should be no higher than 53 KIAS.
