SERVICE LETTER SL49 35A-51650

1. Release Date: 06/10/2021
2. Service Letter No.: SL49 35A-51650
3. Subject: Safety Wires
4. Part/Assembly No.: 35A-51650
5. Float Model Affected: 3400
6. Compliance: **Mandatory** **Recommended** **Optional**
7. Approval: All information provided is in accordance with approved data.
8. Corrective Action: See below.
9. Time Required: 1 hour
10. Payments: Credit to Customer Under Warranty Customer Pays

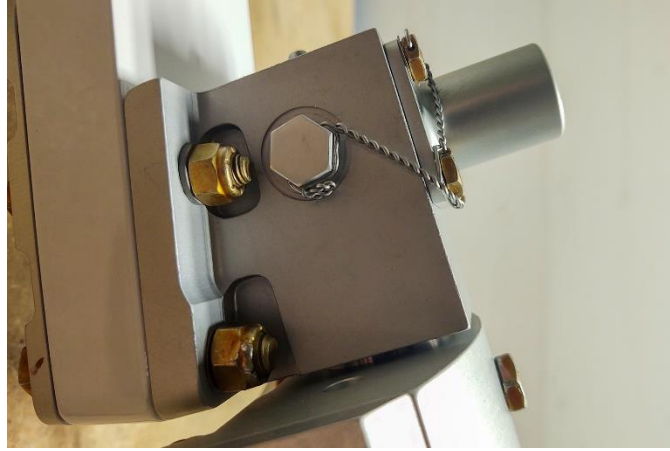
Figure 1 Left Hand Side

It was brought to our attention that Ø.032 safety wire was not used according to type design on the lower nose gear assembly of 3400 floats. Safety wire Ø.020 was used instead. This does not affect the safety of the floats as a double twist method was used with the Ø.020 safety wire; however, during the next inspection, if appropriate, replace with Ø.032 wire.

Affected assembly area, showing an example installation:

INSTALL SAFETY WIRE OR SAFETY CABLE WHERE NOTED.

- A. MS20995C32 SAFETY WIRE; OR
- B. AS3510-20-18K SAFETY CABLE OR PER TABLE 1; AND
- C. INSTALLATION METHODS AND TECHNIQUES IN ACCORDANCE WITH AC43.13-1. CHAP. 7, SEC. 7 (SAFETY WIRE ONLY) OR AS567.
