SERVICE LETTER SL51 66-11200 & 66-12200

1. Release Date: 11/17/2021
2. Service Letter No.: SL51 66-11200
3. Subject: Water Rudder Rigging Installation
4. Part/Assembly No.: 66-11200 and 66-12200
5. Float Models Affected: 6650 and 6750 on Daher KODIAK 100 AMPHIBIAN OR SEAPLANE
6650 Model Floats, Serial Numbers – 184-185 and previous
6750 Model Floats, Serial Numbers – 106-107 and previous
6. Compliance: Mandatory Recommended Optional
7. Approval: All information provided is in accordance with approved data.
8. Corrective Action: Non-required.
9. Estimated Time Required: 1.5 hours
10. Payments: Credit to Customer Under Warranty Customer Pays

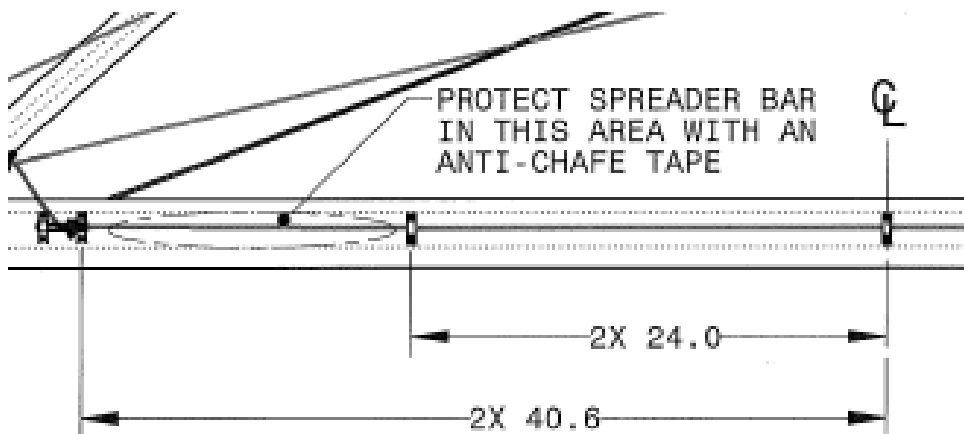
WAS:

The balance cable is chafing paint from the rear of the rear spreader, likely due to turbulence in that region. This service letter is recommending the addition of a set of cable guides (56-15270) to the spreader to prevent chafing as well as using anti-chafe tape.
