SERVICE LETTER SL52 65-46010

1. Release Date: 11/17/2021
2. Service Letter No.: SL52 65-46010
3. Subject: Corrosion Preventive Sealant
4. Part/Assembly No.: 65-46010
5. Float Model Affected: 6650 on Daher KODIAK 100 AMPHIBIAN
6650 Model Floats, Serial Numbers – 184-185 and previous
6. Compliance: Mandatory Recommended Optional
7. Approval: All information provided is in accordance with approved data.
8. Corrective Action: Non-required.
9. Time Required: NA
10. Payments: Credit to Customer Under Warranty Customer Pays

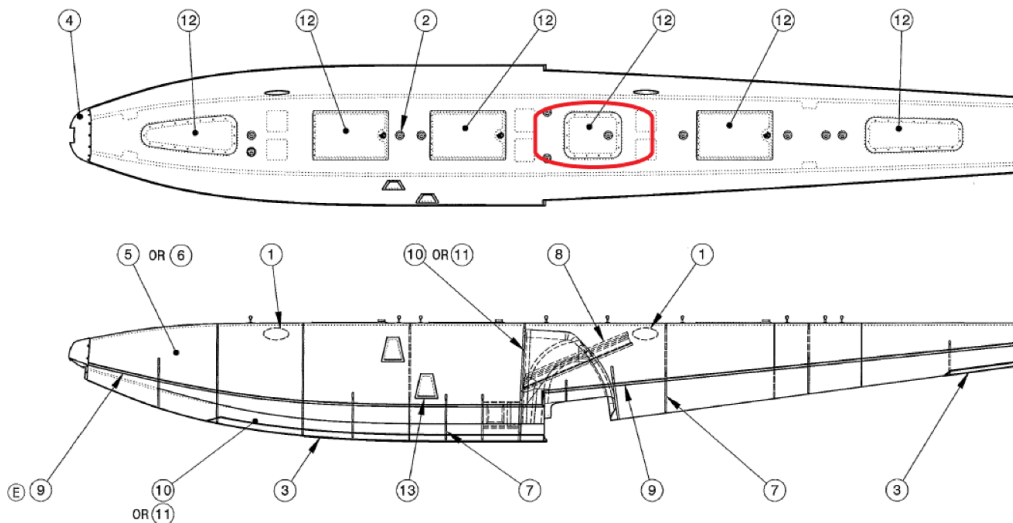
This service letter is more of an advisory and inspection that could be accomplished at the next 100 hour inspection that may help diagnose issues such as inoperable or intermittent gear light(s) and/or false audibles with the float gear advisory system.

The figure below shows where to inspect.

1. Remove access panel at main landing gear to gain access to 65-46010 electrical wiring.
2. It may be required to remove wedge clamp(s) to assist with the visual inspection of the wire bundles.
3. Inspect the individual wires for cuts, nicks, etc. and corrosion where the shielding has been removed.
4. If damage or corrosion is found, replace wire set or affected section of wire.

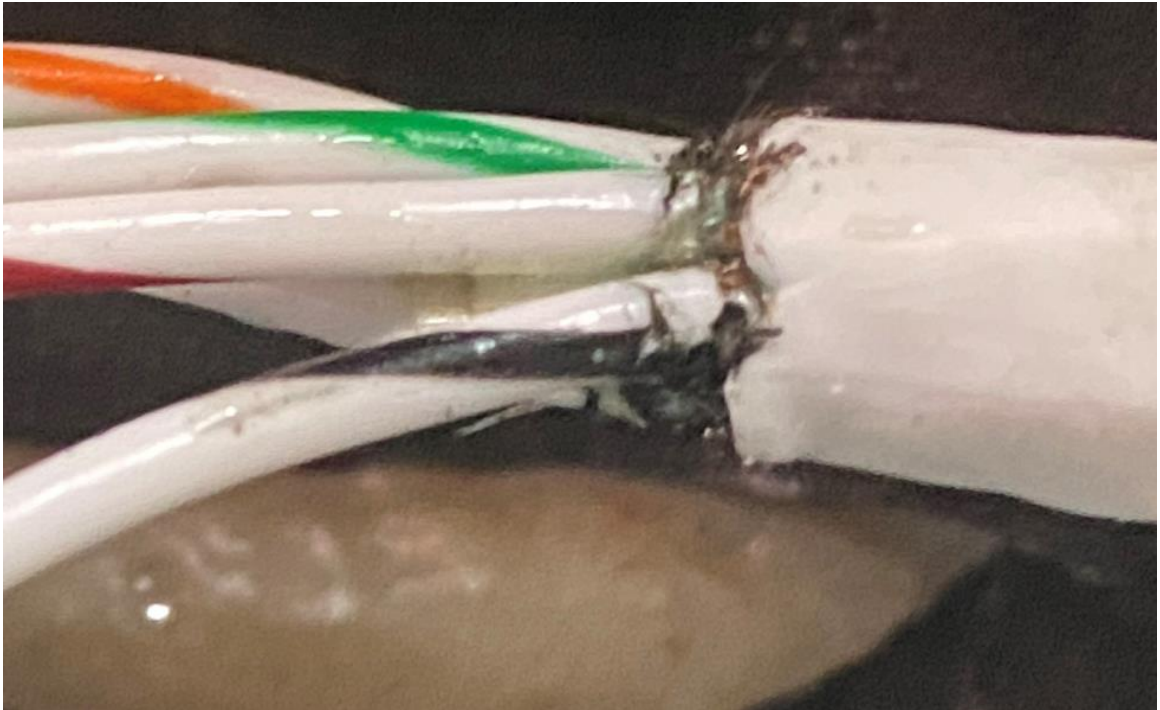
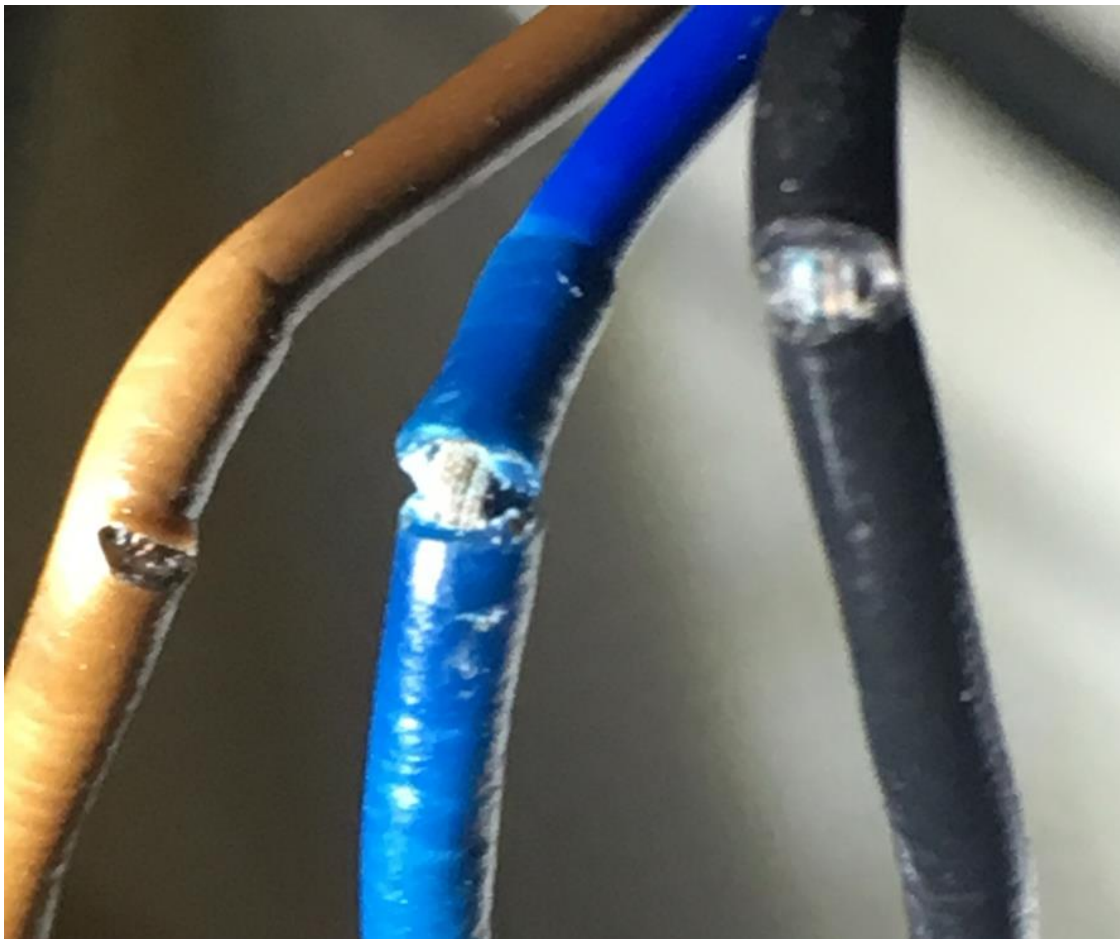
Small nicks in the insulation of wires when stripping external shielding from wire bundles can cause premature corrosion on wires. Aerocet recommends use of tin-and solder techniques for splices and terminations and use of corrosion-preventative sealant (See Table 1) with heat-shrink tubing for best performance.

The pictures that follow are examples of what to look for.
