**Service Letter #:** SL04-35A-45025

**Part/Assembly #:** 35A-45000 Main Gear Installation, Actuator Mount

**Float Model Affected:** Model 3400 (All)

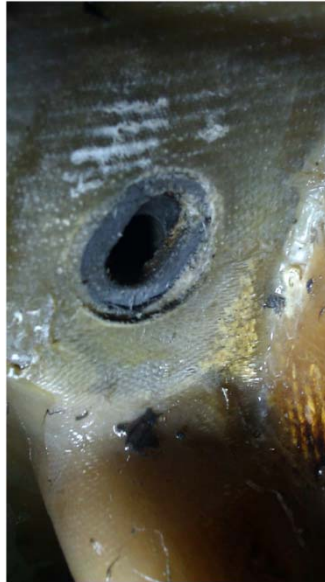
- 6) Visually inspect (with the aid of flashlights, mirrors, etc.) the condition of the bolt hole. A worn hole will have become oblong, allowing some movement of the actuator and allowing water leakage in this area. This condition is the result of wear caused while the actuator is in the retracted position - the main gear in the deployed condition. The hydraulic actuator exerts a great amount of force

between this hole and the stop bracket (not shown) in the gear well. Normal wear, accentuated by debris is the most likely, but not the only possible cause.

**Figure 1 – Showing inspection Side view. (See Figure 2 for Top)**

Aerocet offers a reinforcement kit, 35A-K45025 which increases the bearing area around the hole by bonding a reinforcement to the affected area. This information will also become available in later versions of the Aerocet service and maintenance manual and Illustrated Parts List.

If this condition is found during inspection, then follow the instructions offered in the drawing provided in the kit before returning the aircraft to service.
