Service Letter #: SL05-56-15145

Part/Assembly #: 56-15145/56-15170 Tie Rod Fitting [Inspection & Replacement of]

Float Model Affected: Aerocet Model 5850 Twin Seaplane Float installation on DeHavilland DHC-2 "Beaver" (All)

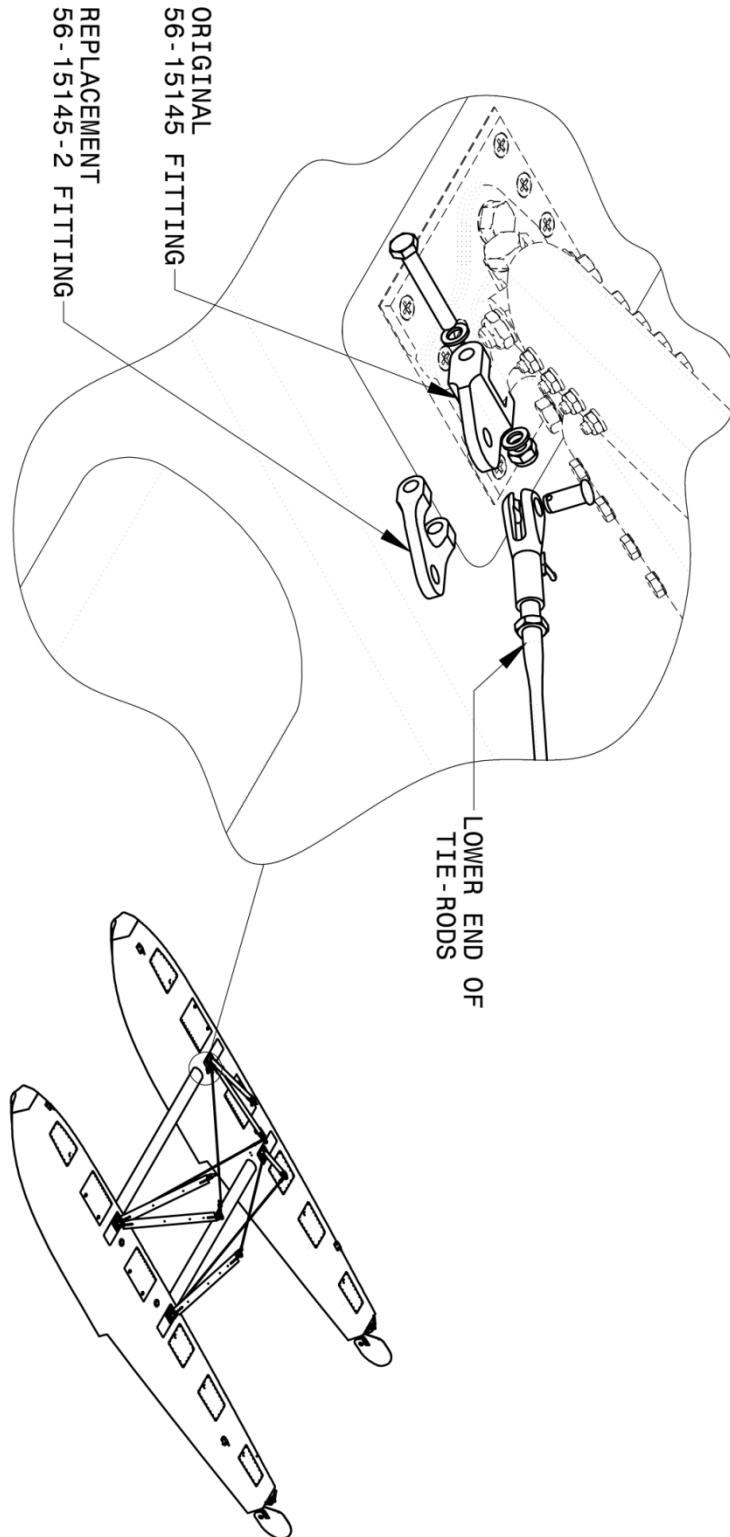
Figure 1 - Showing lower tie rod installation
(Reference Service Manual, Parts Catalog, Figure 17)

Symptom: Reported corrosion of aluminum fitting beneath tie rod clevis in parts with extensive marine service and prolonged inspection intervals. Regular inspection at normal intervals will prevent possible failures due to corrosion-weakened fittings.

During next regular inspection per Aerocet Service Manual, A-10034, Rev 1 or later, include partial disassembly of the lower ends of the tie rods at the Aerocet fittings for all tie rods (crossing wires). Particular attention should be focused beneath the tie rod clevises for indications of corrosion. Parts exhibiting corrosion should be replaced.

Original 56-15145 (now designated with a "-1") is easily identified as painted aluminum. Replacement part, 56-15145-2, is constructed from corrosion resistant steel (stainless), not painted.
