Service Letter #: SL21 66-47200

Float Model Affected: Aerocet Model 6650 floats

Affected: Hydraulic Pump Motor

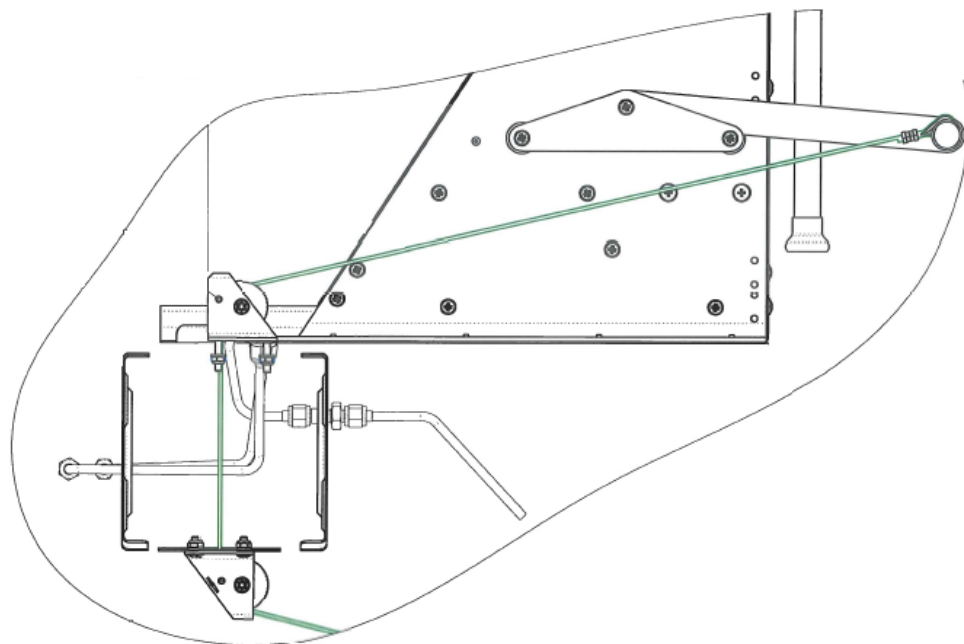
1. Aerocet is sending to you part # 66-47200 which is the complete pedestal, hydraulic assembly so that you will not experience significant down time.
2. Recommend moving pilot seat full aft or removing altogether for easy access.
3. Remove cable from water rudder retract handle.

Caution: Weight of rudder will need to be lessened to ease removal.

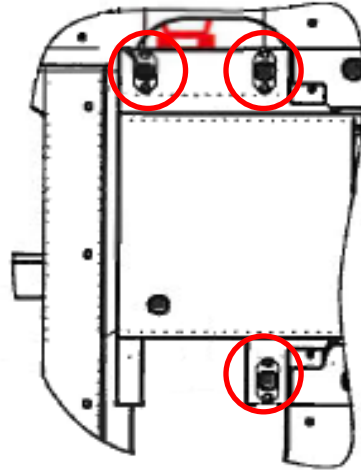
4. Remove 3 screws from hydraulic shield.

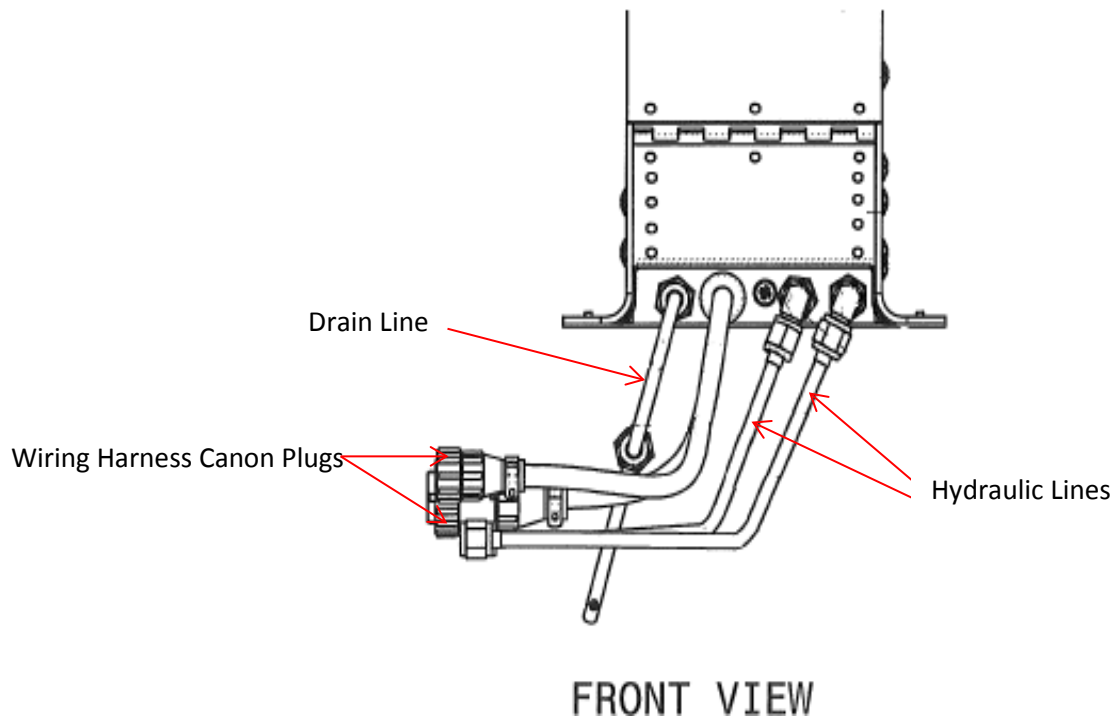
6. Disconnect 2 hydraulic lines and one drain line from front of pedestal.
Cap and plug as necessary.

7. Under floor, disconnect two-wire harness canon plugs. (See above)
8. Remove pedestal from aircraft
9. Replace existing pedestal with supplied pedestal in same order as removal.
10. Call (208) 448-0400 for shipping voucher number and ship existing unit back to:
