# SL56 35A-60200 SERVICE LETTER

1.	Release Date: 08/22/2022				
2.	Service Letter No.: SL56 35A-60200 Rev I/R				
3.	Subject: Bi-Directional Hydraulic Electric Pump and Hydraulic Intake Pipe				
4.	Part/Assembly No.: 35A-60200 and 35A-60235				
5.	5. Float Model (s) Affected: 3400 Aerocet Floats				
6.	Compliance: ☐ Mandatory ☑ Recommended ☐ Optional				
7.	Approval: All information provided is in accordance with approved data.				
8.	Corrective Action: Non-required.				
9.	<b>Time Required:</b> Approximately 1.5 hrs. not including lifting of the aircraft, bleeding the system and completing gear swings.				
10.	Payments: ☐ Credit to Customer ☐ Under Warranty ☒ Customer Pays				
11.	Call Parts Department (208) 448-0400 for Parts Kit

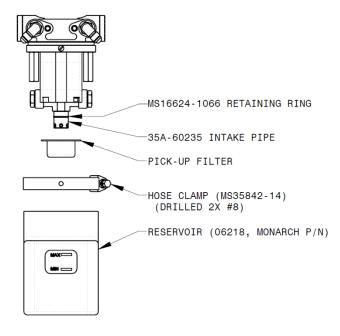
## **Hydraulic Electric Pump Exploded View, Simplified**

A retaining ring and safety wire has been added to improve suction screen installation on the hydraulic pump. Additionally, a snap ring groove to the hydraulic intake pipe was added to create a hard stop for the suction screen to seat against.
