SERVICE LETTER SL59 66-12020

2. **Service Letter No.:** SL59 66-12020

3. **Subject:** Torquing of eyebolt

5. **Float Model (s) Affected:** 6650

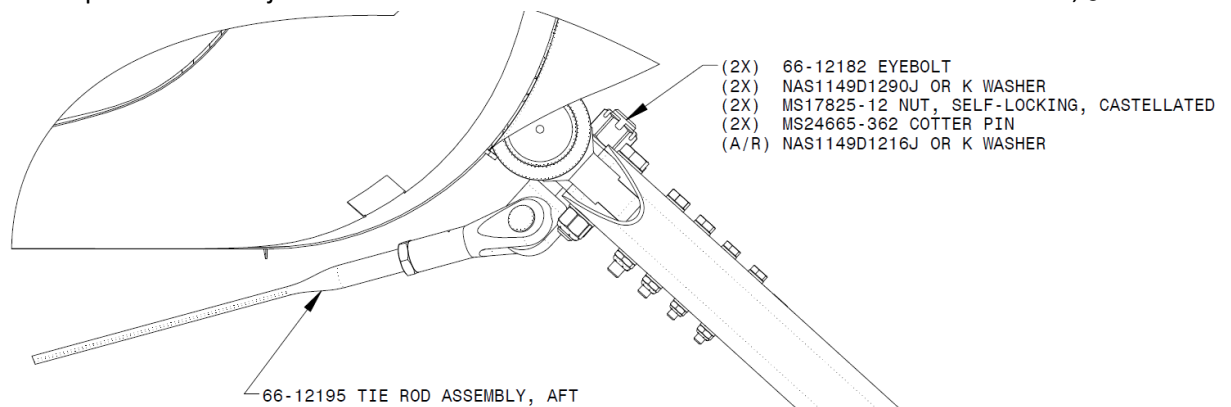
2. **66-12182 Eyebolt Torque Check:** Final torque of the eyebolt nut, MS17825-12, shall be at least 100ft.-lb. and shall not exceed 175 ft.-lb. Existing installations may be re-torqued if the installed torque was less than 210 ft.-lb. Use the following instructions to determine the installed torque.

Figure 1 - SHOWING MID/REAR STUT AT MLG TRUNION, LHS (View facing aft, from front.

- A. Remove MS24665-362 Cotter Pin.
- B. Assistant: Firmly secure aft tie rod with an adjustable wrench, or equivalent tool.
- C. Apply torque to the MS17825-12 Nut, starting at the minimum 100 ft.-lb. torque and until a slight turning of the nut is achieved, or a maximum installed torque value of 210 ft.-lb. is met.
- D. If no movement is detected before 210 ft.-lb. is achieved, then REPLACE 66-12182 Eyebolt in accordance with **3. Eyebolt Installation Procedure** below.
- E. If movement is achieved before 210 ft.-lb. is reached, then re-torque the nut 100 ft.-lb. to 175 ft.-lb. and attain cotter alignment.
- F. If 100 ft.-lb. to 175 ft.-lb. final torque cannot be met within cotter alignment, then add NAS1149D1216J or K washer beneath the nut using the instructions below for eyebolt installation.
- G. Install cotter and proceed to **4. Completion**, following.

- Loosen rear tie rods and replace rear eyebolts (66-12182). (Maintain eyebolt alignment using an adjustable wrench or equivalent.)
 - Tighten the eyebolt nut enough to take up slack (Approximately 10-12 ft-lb. torque).

- Tighten tie rod assemblies to remove any bow and assure alignment of eyebolts in clevis slots.
 - Hold the tie rod in place with an adjustable wrench (or equivalent tool) and apply final torque of 100-175 ft-lb. Add one NAS1149D1216J or K if necessary to align cotter hole and stay within maximum torque range. (This washer will produce about ¼ turn (90°) change in nut alignment.)
