# SERVICE LETTER SL31 66-12020

1. **Service Letter No.:** SL31 66-12020
2. **Release Date:** August 29, 2017
3. **Reason for Change:** Dimensions between key areas of floats
4. **Part/Assembly No.:** Drawing 66-12020
5. **Float Model Affected:** 6650
6. **Disposition of Product in Field:** Informational Only
7. **Approval:** All information provided is in accordance with approved data.
8. **Corrective Action:** (Informational Only)
9. **Time Required:** N/A
10. **Payments:** N/A

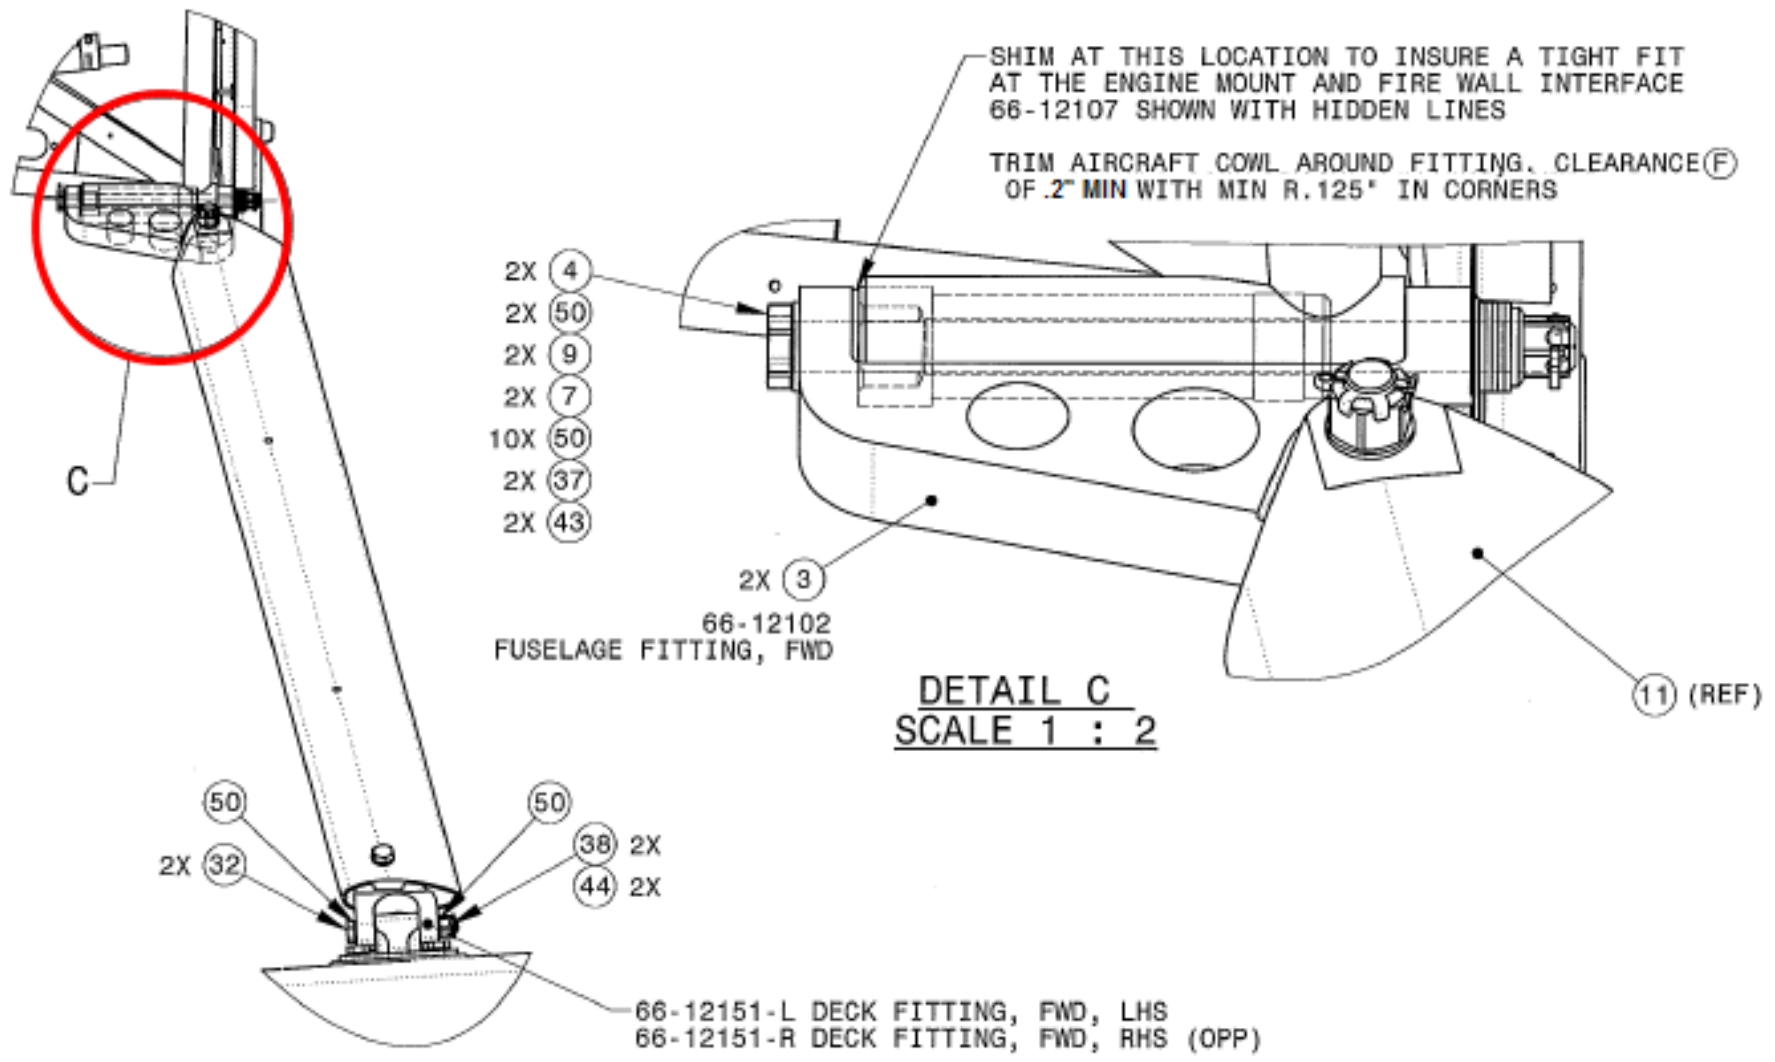
**Figure 1: Shim Location 66-12020**

1. There should be a minimum .2" opening around the fitting including the fuselage flange ahead of the firewall. See Figure 1 below.
2. There is some rotational movement on the front fitting. This gap should be opened to keep this from happening.

3. Any damage can be cleaned up as there is nothing structural in this area on the flange of metal or cowling.
4. Rotations for takeoff (VR1) should be no higher than 53 KIAS.
